Keeping the Lights On with Motion Amplification™

► AGL Loy Yang

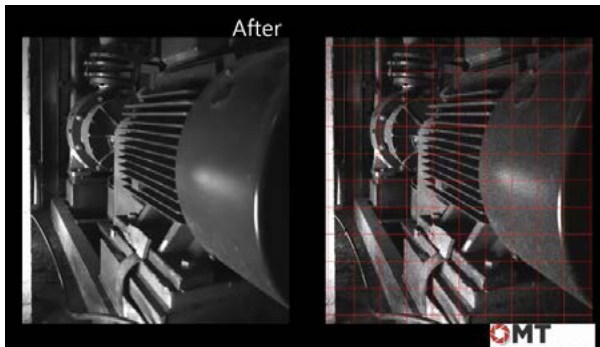
Optical Motion Technologies (OMT) were contracted to apply RDI's Motion Amplification™ (MA) technology to solving the long running problem on 1-SCP-2. From arriving at the location of the SCPs in the power station, setting up the video camera acquisition system and then collecting nine MA videos took less than one hour. This hour included the time to analyze the results all of which was done in the field. The process involved taking wide angle 'whole of machine' videos, analyzing them in the field and then honing in with zoomed videos on the root cause of the problem. It was clear from the MA videos that the problem was a soft foot condition between the pump base frame and skid base plate. In fact, there was a twisting operational deflection shape of the pump base frame. During a scheduled outage, a series of fillet welds were made across the suction end the pump base frame to the skid base plate. When the pump was returned to duty service the high lateral motion and vibration had been reduced by more than 70% and was now less than 5 mm/sec RMS. The solution to this problem was achieved through the application of RDI's Motion Amplification™ technology for a fraction of the time and cost already incurred.

Click the photo to watch a video.

- Captured Motion Amplification™ (MA) videos and diagnosed the fault in the field within 1 hour.
- Visualization of the root cause (structural fault) of the high vibration that has been undiagnosed for more than 10 years.
- Simple and inexpensive remediation work during a scheduled outage reduced by more than 70 percent.
- The pump was returned to duty service rather than stand-by
- Solution implemented at a fraction (1%) of the cost of previous attempted
