# Keeping the Lights On with Motion Amplification™

There are two (duty and stand-by) Stator Coolant Pumps (SCP) critical to the operation of each 500+ megawatt turbo generator at the Loy Yang Power Station. One of the two SCPs for Unit 1 turbo generator has had a long history, more than 10 years, of high lateral vibration, sometimes reaching 20 mm/sec RMS.

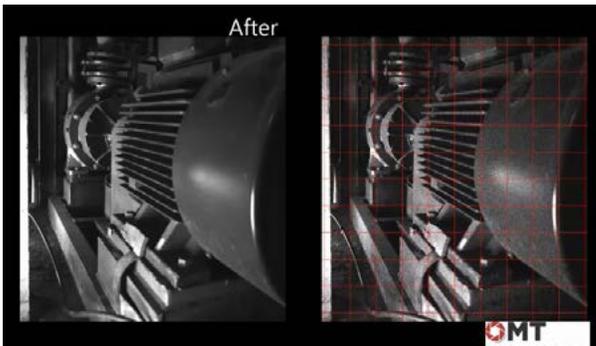
Optical Motion Technologies (OMT) were contracted to apply RDI's Motion Amplification™ (MA) technology to solving the long running problem on 1-SCP-2. From arriving at the location of the SCPs in the power station, setting up the video camera acquisition system and then collecting nine MA videos took less than one hour. This hour included the time to analyze the results all of which was done in the field. The process involved taking wide angle 'whole of machine' videos, analyzing them in the field and then honing in with zoomed videos on the root cause of the problem. It was clear from the MA videos that the problem was a soft foot condition between the pump base frame and skid base plate. In fact, there was a twisting operational deflection shape of the pump base frame. During a scheduled outage, a series of fillet welds were made across the suction end the pump base frame to the skid base plate. When the pump was returned to duty service the high lateral motion and vibration had been reduced by more than 70% and was now less than 5 mm/sec RMS. The solution to this problem was achieved through the application of RDI's Motion Amplification™ technology for a fraction of the time and cost already incurred.

Click the photo to watch a video.

- Captured Motion Amplification™ (MA) videos and diagnosed the fault in the field within 1 hour.
- Visualization of the root cause (structural fault) of the high vibration that has been undiagnosed for more than 10 years.
- Simple and inexpensive remediation work during a scheduled outage reduced by more than 70 percent.
- The pump was returned to duty service rather than stand-by
- Solution implemented at a fraction (1%) of the cost of previous attempted
