Keeping the Lights On with Motion Amplification™

► AGL Loy Yang

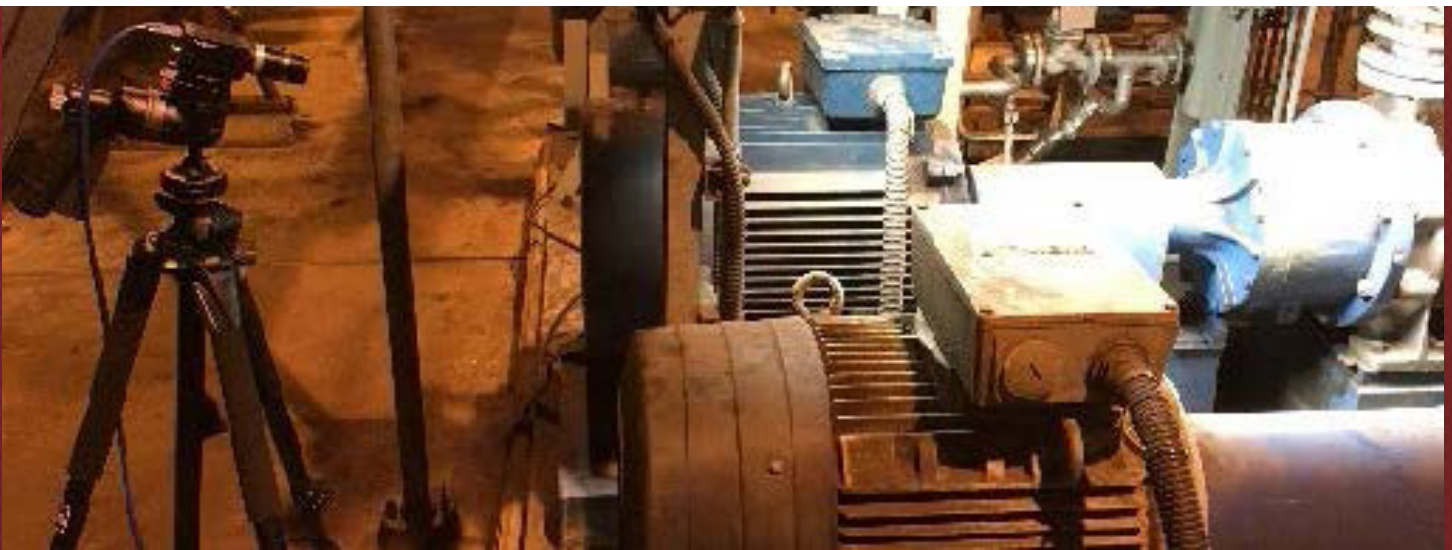
There are two (duty and stand-by) Stator Coolant Pumps (SCP) critical to the operation of each 500+ megawatt turbo generator at the Loy Yang Power Station. One of the two SCPs for Unit 1 turbo generator has had a long history, more than 10 years, of high lateral vibration, sometimes reaching 20 mm/sec RMS.

- Captured Motion Amplification™ (MA) videos and diagnosed the fault in the field within 1 hour.
- Visualization of the root cause (structural fault) of the high vibration that has been undiagnosed for more than 10 years.
- Simple and inexpensive remediation work during a scheduled outage reduced by more than 70 percent.
- The pump was returned to duty service rather than stand-by
- Solution implemented at a fraction (1%) of the cost of previous attempted
