RDI CASE STUDY

Company: AGL Loy Yang
 Location: Latrobe Valley, Victoria, Australia
 Service Provider: Optical Motion Technologies

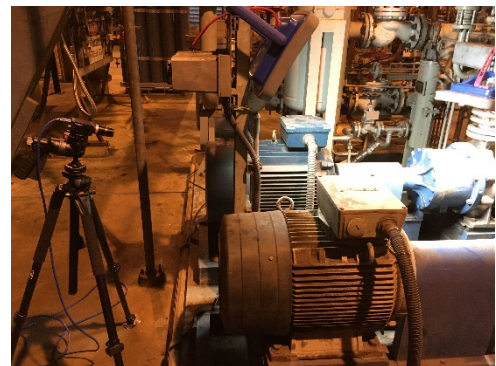
There are two (duty and stand-by) Stator Coolant Pumps (SCP) critical to the operation of each 500+ megawatt turbo generator at the Loy Yang Power Station. One of the two SCPs for Unit 1 turbo generator has had a long history, more than 10 years, of high lateral vibration, sometimes reaching 20 mm/sec RMS. There have been many attempts to remedy the problem at an estimated material cost of AU\$160k. This does not take into account the estimated labor cost of 500+ man hours and loss of power generation revenue. Some of the attempts to remedy the problem include: laser alignment, base frame spot welds, bracing of pipework, fitment of flexible bellows to the pump suction and discharge pipework, pump replacement x2, motor replacement, coupling replacement, etc...

Optical Motion Technologies (OMT) were contracted to apply RDI's Motion Amplification™ (MA) technology to solving the long running problem on 1-SCP-2. From arriving at the location of the SCPs in the power station, setting up the video camera acquisition system and then collecting nine MA videos took less than one hour. This hour included the time to analyze the results all of which was done in the field. The process involved taking wide angle 'whole of machine' videos, analyzing them in the field and then honing in with zoomed videos on the root cause of the problem. It was clear from the MA videos that the problem was a soft foot condition between the pump base frame and skid base plate. In fact, there was a twisting operational deflection shape of the pump base frame. During a scheduled outage, a series of fillet welds were made across the suction end the pump base frame to the skid base plate. When the pump was returned to duty service the high lateral motion and vibration had been reduced by more than 70% and was now less than 5 mm/sec RMS. The solution to this problem was achieved through the application of RDI's Motion Amplification™ technology for a fraction of the time and cost already incurred.
